Manhole Inspection Summary

Manhole # S15QQ1008MH

Insp Date: **11/13/06 11:30 AM**

Location Address: **20 CATALPA CT**

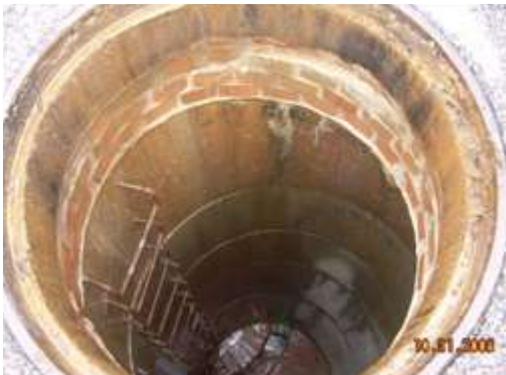
Defect

☒ **Leaks**

Infiltration: ☐ None ☒ **Joint** ☐ Cracks ☐ Mortar ☐ Roots ☒ **Wall**

Frame leaks. Adjustment infiltration.

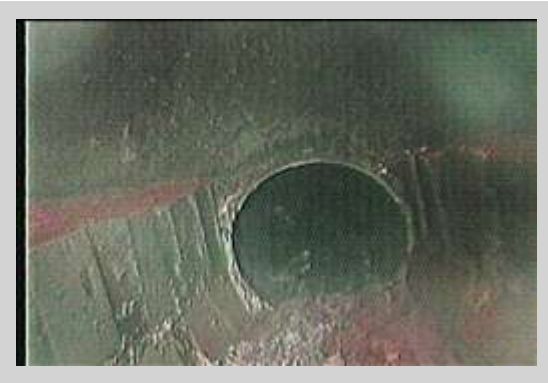
Pipe Out @ 12 O'Clock

Deposits: ☐ None ☐ Mud ☐ Sludge ☒ **Debris** ☐ Grease

Silt Depth: **1** (in.) Deposits Extent: **Light**

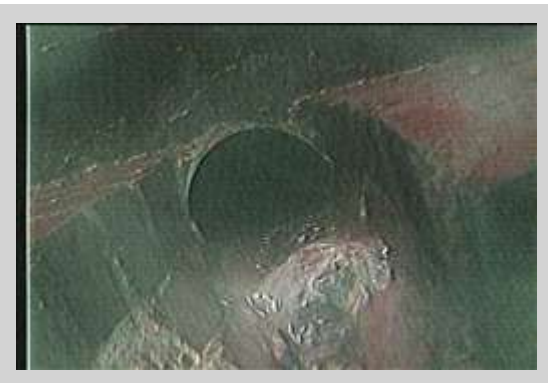
Pipe In @ 4 O'Clock

Deposits: ☐ None ☐ Mud ☐ Sludge ☒ **Debris** ☐ Grease

Silt Depth: **1** (in.) Deposits Extent: **Light**

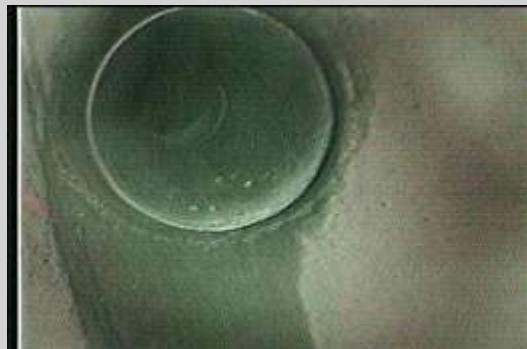
Pipe In @ 7 O'Clock

Infiltration: **Evidence**

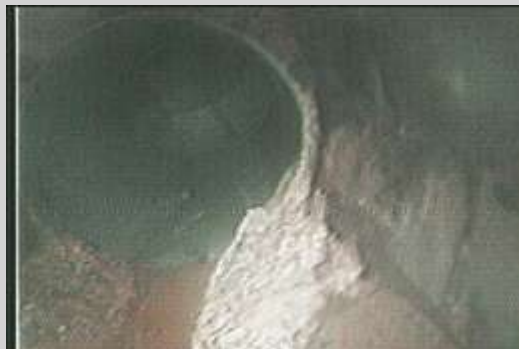
Drop In @ 7 O'Clock

Drop: **Outside** Rod and Bar

Drop Condition: **Open**
